Inspection Report

Prospec Home Inspections

Sample Street

Building Inspection

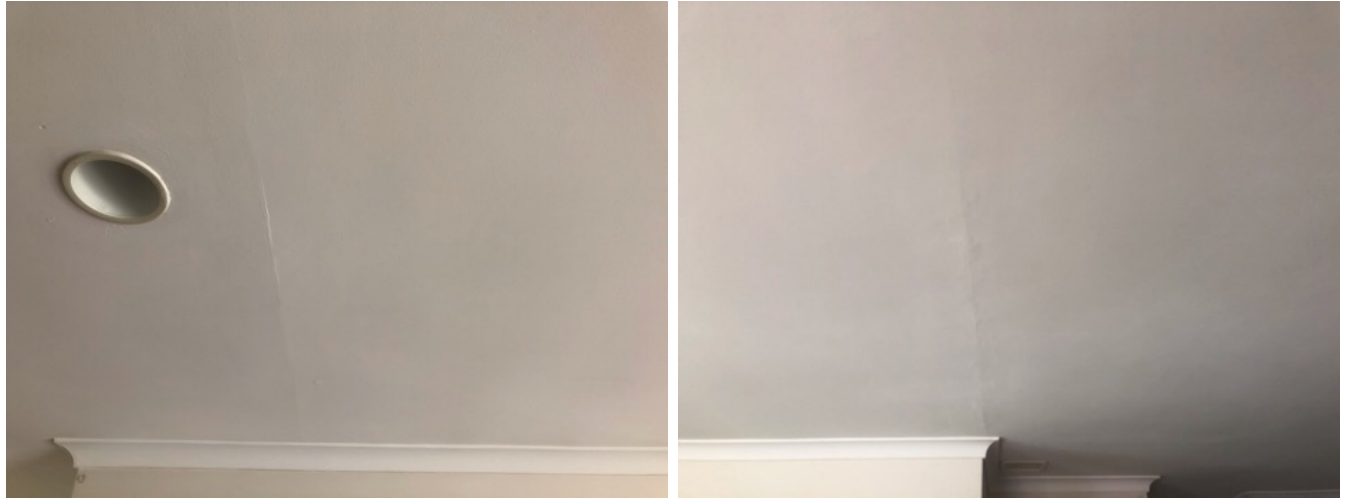
There is some minor movement cracking to the ceiling sheet joints. This is commonly caused by no back blocking to the ceiling joints and may require maintenance, however is not considered a structural defect.

There were some minor cornice cracking present. Minor maintenance may be required.

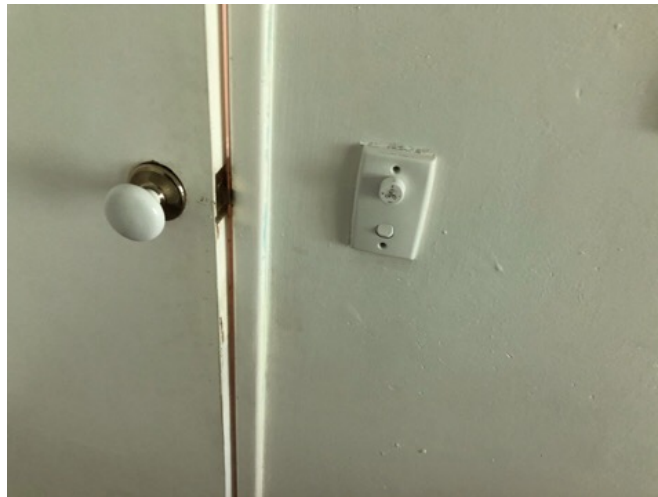
Some doors are binding with the frames and may require minor adjustments.

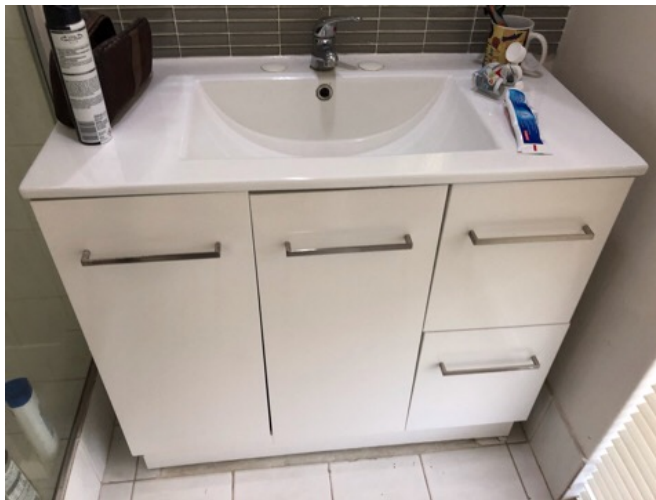
The cabinet doors require adjustments to close correctly.

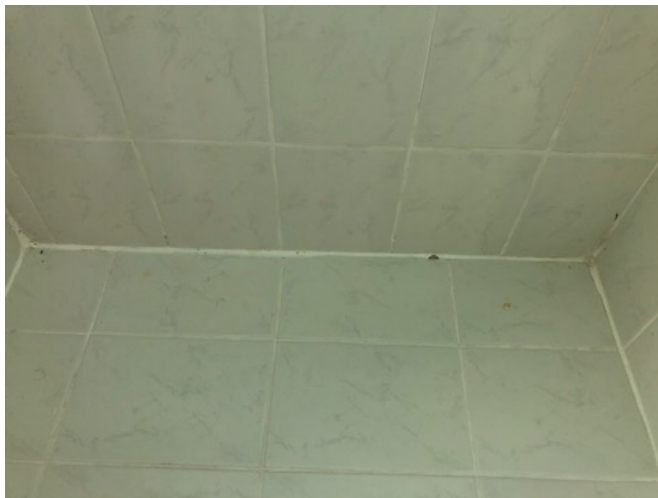
The silicone is in a deteriorated condition. It is advisable to replace.

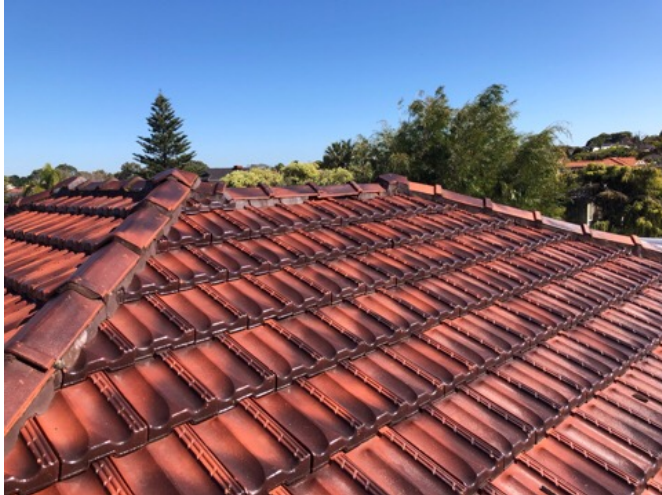
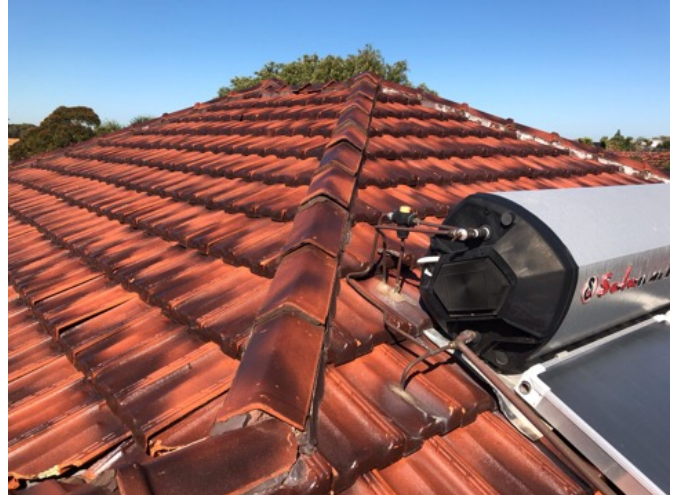
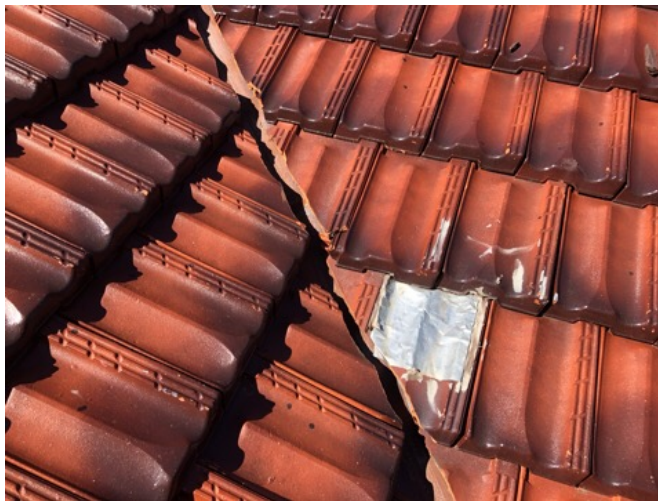
Minor cracking and displacement to the roof tile pointing was observed. The cracking was not considered significant and was not letting in water. Future repairs may be required

Lead flashing was used to cover broken tile. Although not a problem currently it may be advisable to replace the tile in the future.

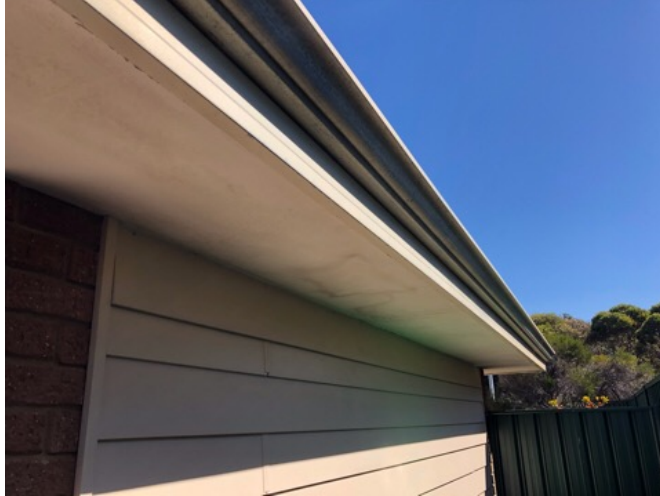
The soffit lining eaves are in a serviceable condition with no significant notable defects. Water staining to the eaves sheets was observed and may require repainting after leaks has been repaired.

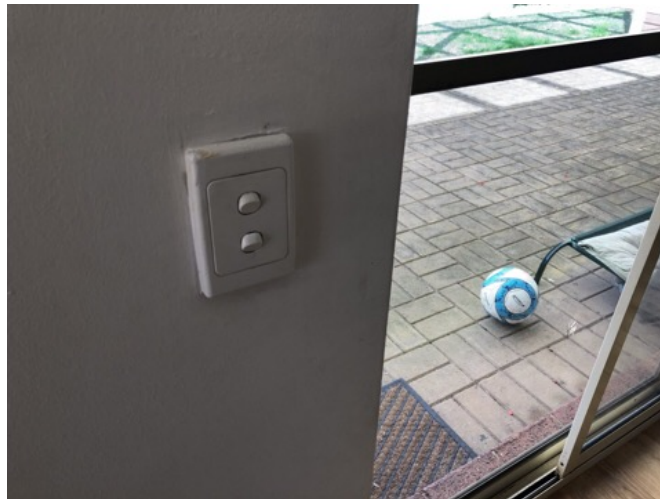
Light switch knob was partially broken and may require future replacing.
