Inspection Report

Prospec Home Inspections

Sample Street

Building Inspection

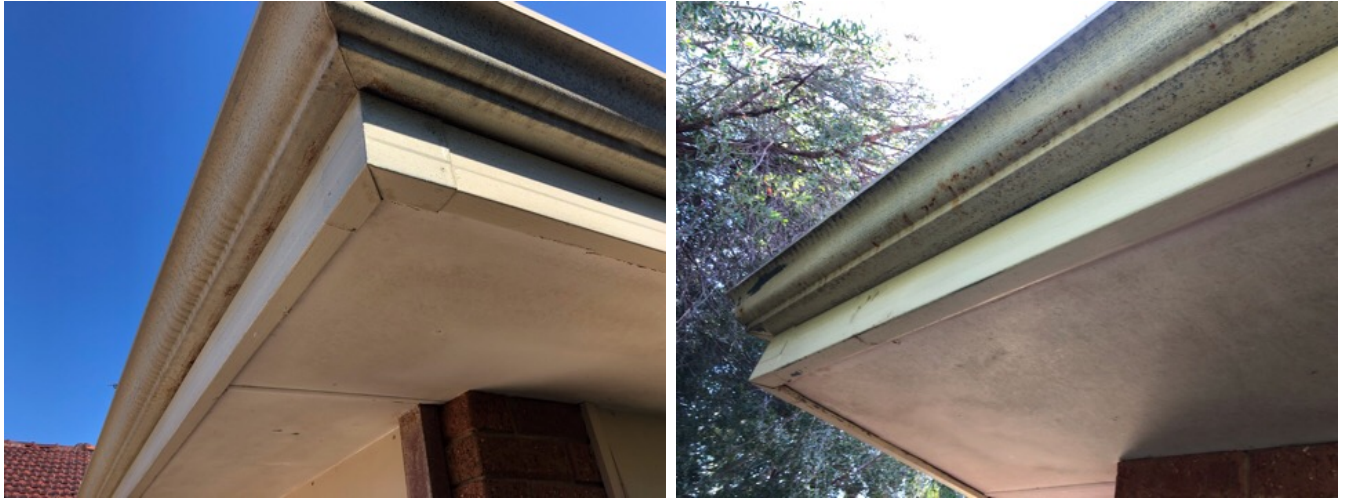
All visible guttering appears in a serviceable condition with no apparent defects at the time of inspection.

Note: periodic maintenance checks should be carried out for rust penetrations and leaks.
